TECHNICAL REPORT HL-92-1

BRUSH CREEK, KANSAS CITY, MISSOURI

Hydraulic Model Investigation

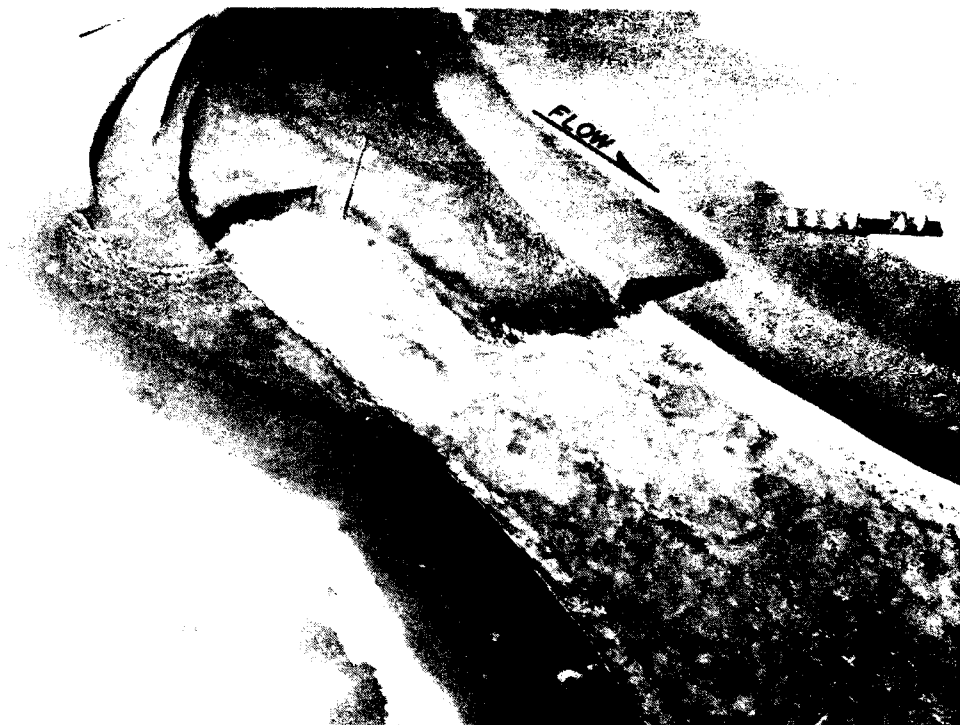
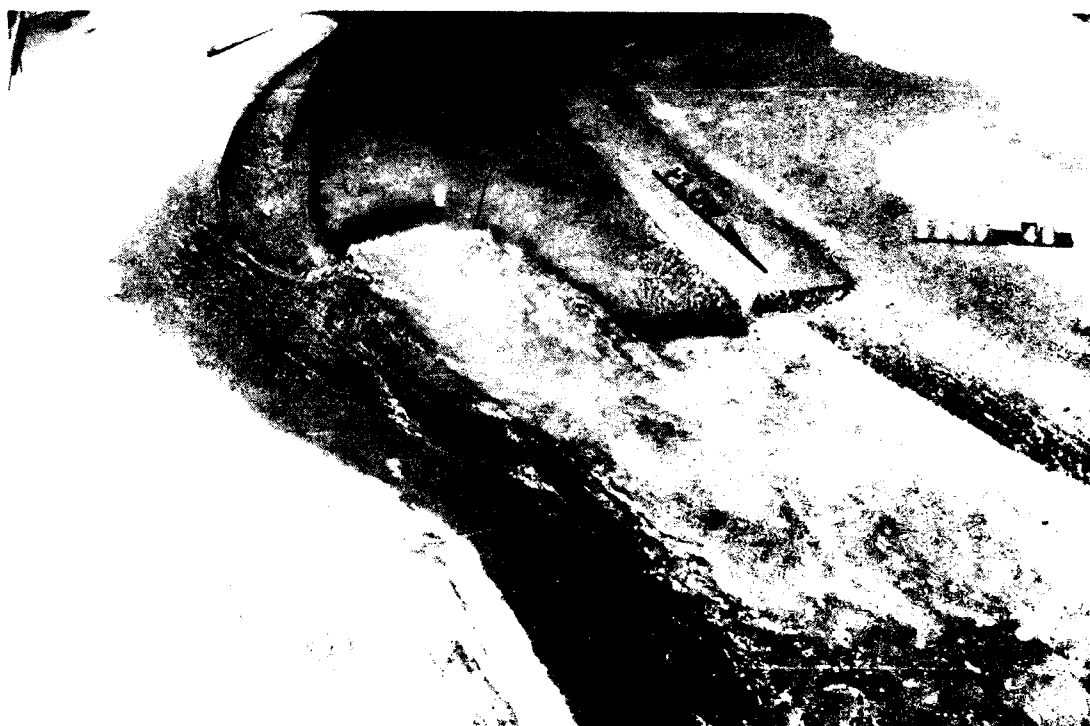
a. 10-year flood

b. 100-year flood

Photo 45. Flow conditions at irregular dam 1 (sta 79+00) (Continued)

c. 500-year flood

Photo 45. (Concluded)

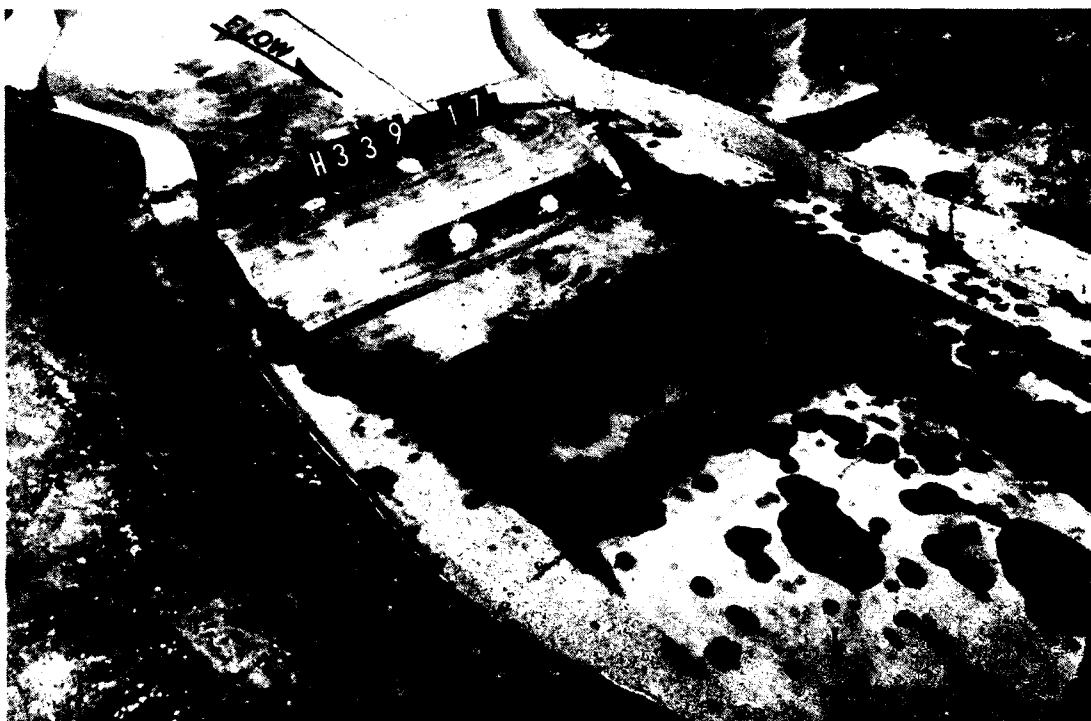
Photo 46. Drop 1, type 1 design stilling basin

69. Type 1 design. An uncontrolled hydraulic jump formed downstream of Roanoke Parkway that had great potential for scour and erosion. To dissipate the energy of the hydraulic jump, a drop structure was needed. Traditional straight drop structures, such as the Saint Anthony Falls type, could not be used because of the high design unit discharge (210 cfs/ft for a 100-year flood) required in this situation. In previous work at the US Army Engineer Waterways Experiment Station involving high unit discharge drop structures on the Santa Ana River, a general design was developed. This type of drop structure (Photo 46) was installed downstream of Roanoke to dissipate energy and improve flow conditions. Details and design information for the type 1 design drop structure are shown in Plate 17. Flow conditions at the drop structure, shown in Photo 47, indicated that the hydraulic jump was contained within the structure and energy dissipation was greatly improved over existing conditions. Downstream water-surface conditions were also improved. Although the drop structure was designed for a 100-year event, satisfactory performance was observed at 500-year discharge conditions.

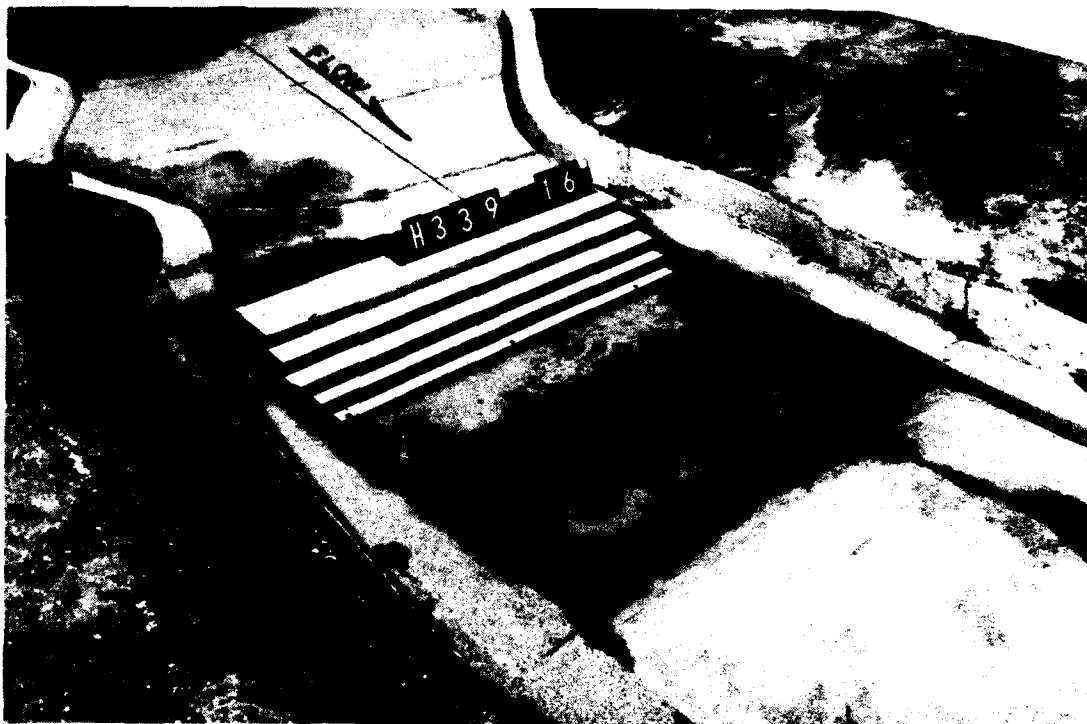
Photo 48. Drop 1, type 2 design stilling basin

70. Type 2 design. In spite of satisfactory performance of the type 1 drop structure, the parabolic curve of the trajectory did not conform to the overall aesthetics of the Park Plan. The curve was broken into steps of approximately 2 ft in height as shown in Photo 48. All other dimensions remained the same (Plate 17). Flow conditions shown in Photo 49 indicated that the stepped trajectory (type 2 design) did not perform as well as the parabolic trajectory (type 1 design).

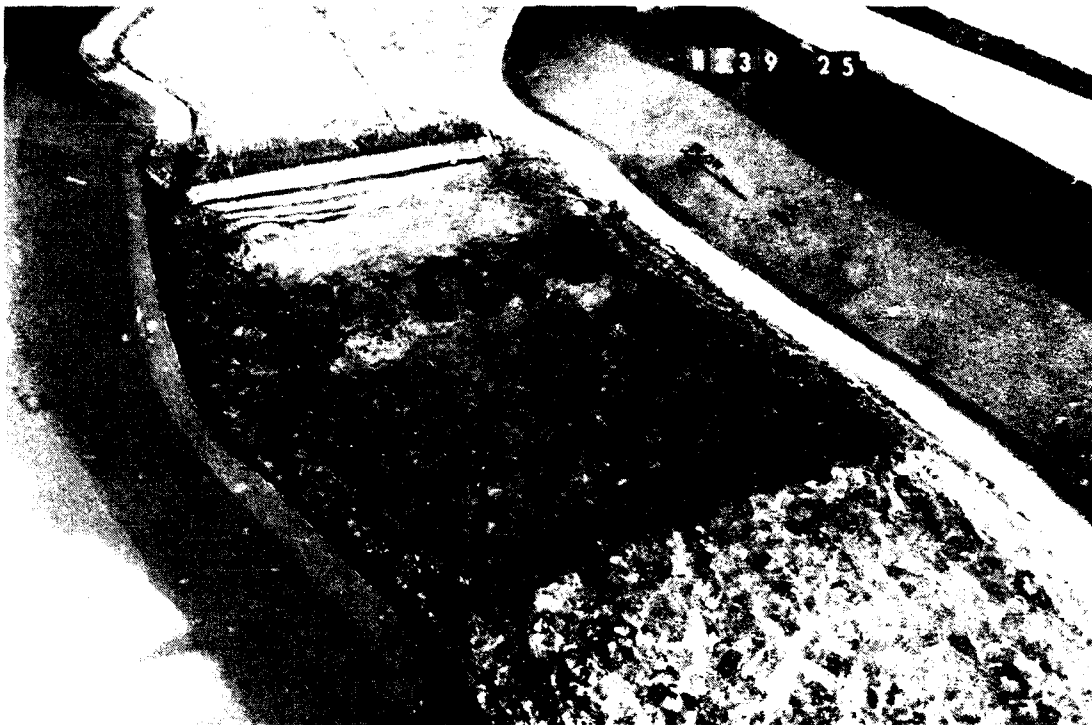
a. 10-year flood

b. 100-year flood

Photo 49. Flow conditions at drop 1, type 2 design stilling basin

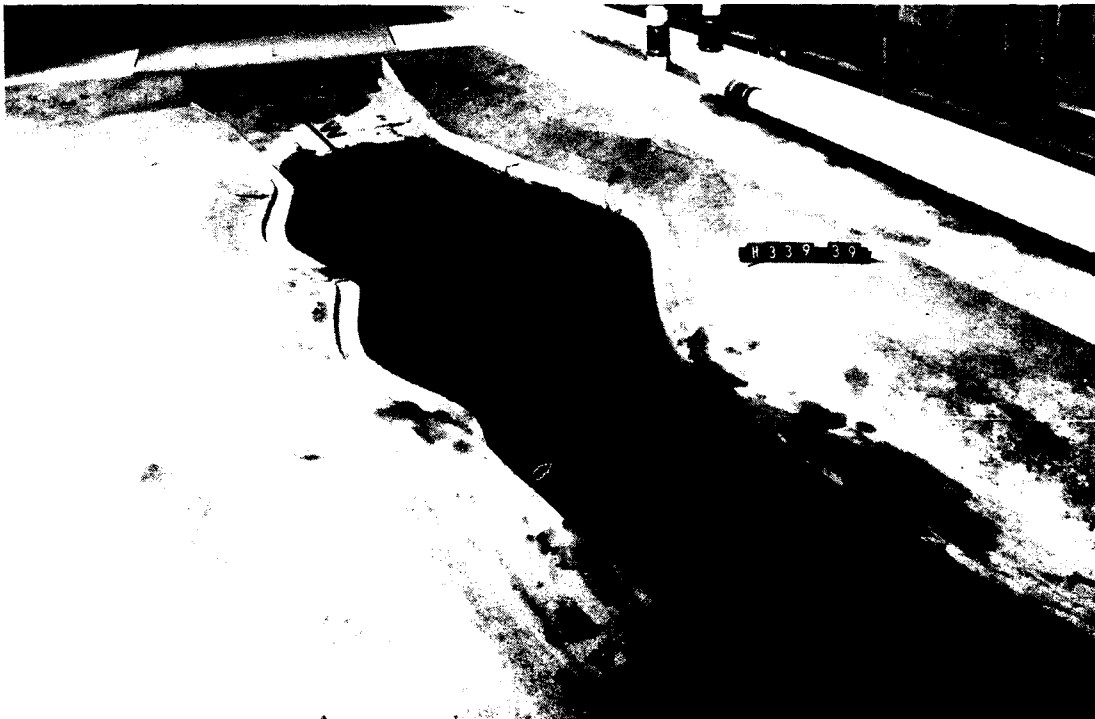
Photo 50. Drop 1, type 4 design stilling basin

72. Type 4 design. Although the type 3 design provided adequate energy dissipation, the roller formed by the hydraulic jump created a significant safety hazard for anyone attempting to float the stream during high flows. Therefore, the drop structure was redesigned with a series of horizontal steps 2 ft high. The steps were arched or horseshoe shaped in the upstream direction for aesthetic reasons. A shallow upstream pool was also added. This was designated the type 4 design and is shown in Photo 50. A plan view and center-line profile of the type 4 design are shown in Plate 19. As expected, flow conditions and energy dissipation were not as good as was observed with the previous design. However, the strong reverse roller was eliminated, which greatly improved safety. Flow conditions with the type 4 design are shown in Photo 51 for the 10-, 100-, and 500-year floods. A subsequent modification was made by placing blocks approximately 4 ft high on the steps at the side-walls. These blocks directed the flow to the center of the channel and dampened the large oblique standing waves previously created. Next, the upstream pool was narrowed with straight walls on both sides of the channel in an

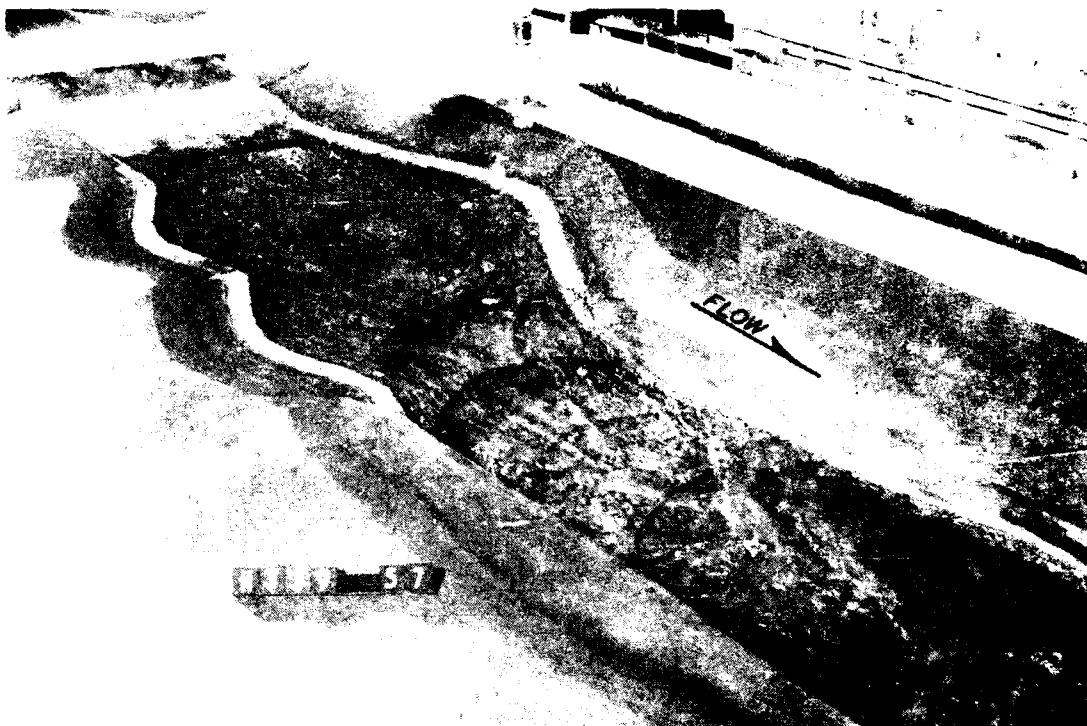
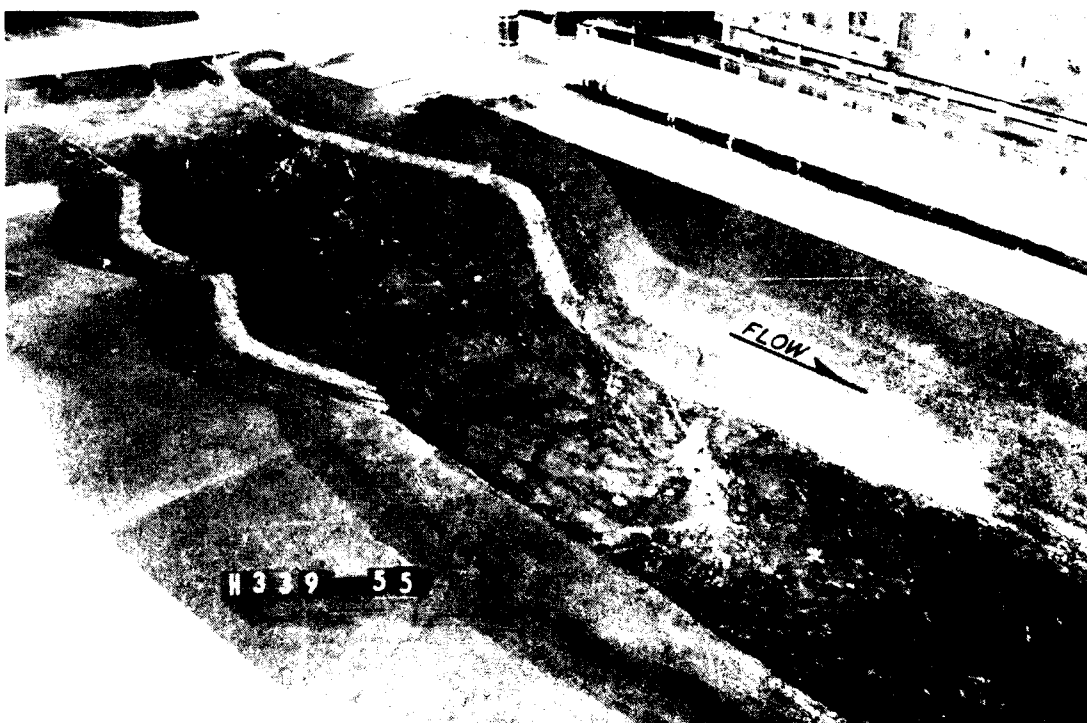
a. 10-year flood

b. 100-year flood

Photo 51. Flow conditions at drop 1, type 4 design stilling basin (Continued)

c. 500-year flood

Photo 51. (Concluded)

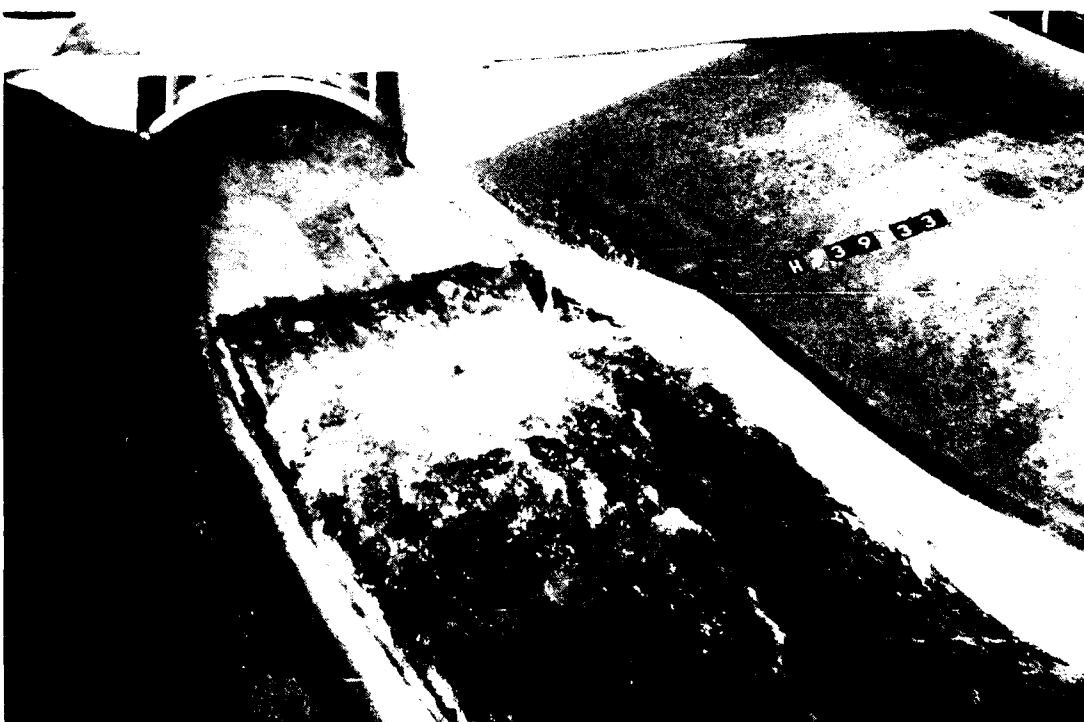
a. 10-year flood

b. 100-year flood

Photo 53. Flow conditions at drop 2, type 1 design stilling basin

73. Type 1 design. It was observed from the various tests conducted that a hydraulic jump will develop just downstream of Troost Avenue. Because of this, a drop structure was required in this vicinity to prevent excessive erosion from occurring. Due to the higher unit discharge in this reach and because of the narrow channel width (70 ft), a drop structure identical to the Roanoke drop structure would not perform satisfactorily. The type 1 design drop structure (Photo 52) was designed for a width of 70 ft and a unit discharge of 287 cfs/ft (100-year flood). Based upon experience gained on the Roanoke drop structure, the Troost drop structure was designed with the longer $X^2 = 4HY$ parabolic trajectory. Details of the type 1 design are shown in Plate 20. Flow conditions with the type 1 design are shown in Photo 53.

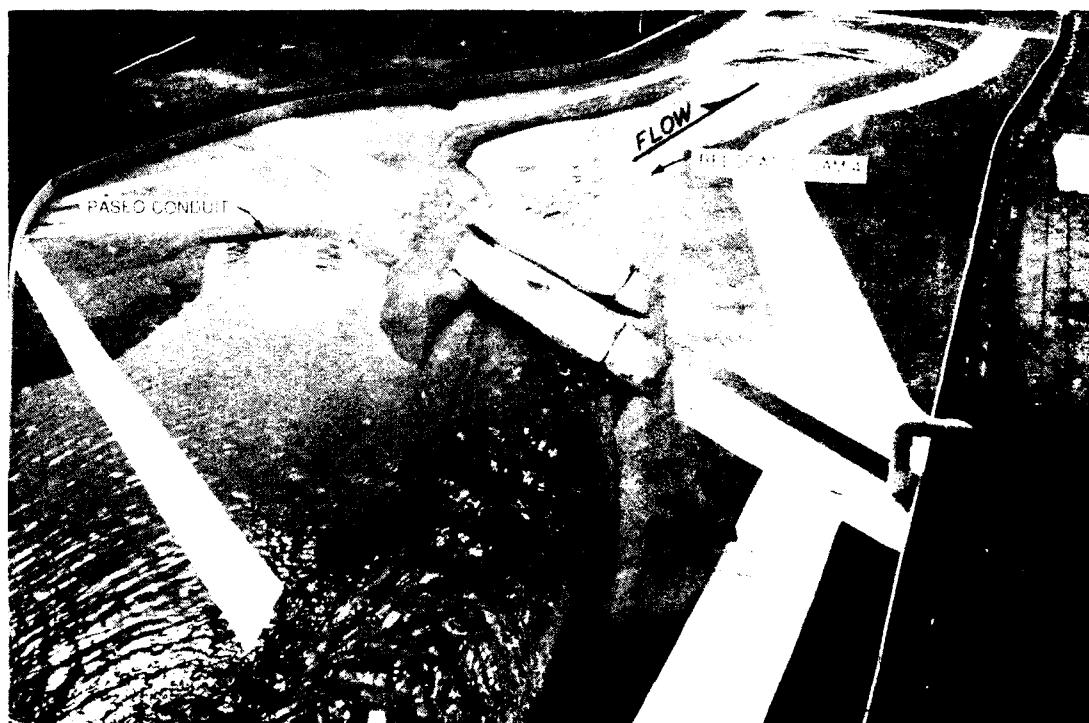
a. 10-year flood

b. 100-year flood

Photo 60. Flow conditions at Paseo realignment with new Paseo bridges, sta 123+00 to sta 147+00 (Continued)

c. 500-year flood

Photo 60. (Concluded)

77. Although flow conditions were improved, the 500-year flood still overtopped the left bank and flooded the low area in the vicinity of the Brush Creek Boulevard-Paseo intersection. This flooding was due to the location of dam 4, which restricted the flow underneath the bridges. Also, the curved alignment of the channel upstream of the Paseo bridges contributed to the problem. Relocation of dam 4 downstream to sta 131+50 improved the situation, but additional refinement was needed. The channel upstream of the Paseo bridges was straightened to remove any curvature. The combination of these modifications, shown in Photo 59, greatly improved the flow conditions in the Paseo area. Flow conditions for the 10-, 100-, and 500-year floods, shown in Photo 60, reveal that the flood impact in this area was greatly reduced when compared with previous conditions.
